First Five-Year Review Report
For Cannelton Industries, Inc. Site
Sault Ste. Marie, Chippewa County, Michigan
August, 2004

PREPARED BY:
U.S. Environmental Protection Agency
Region 5
Chicago, Illinois

Five-Year Review Report

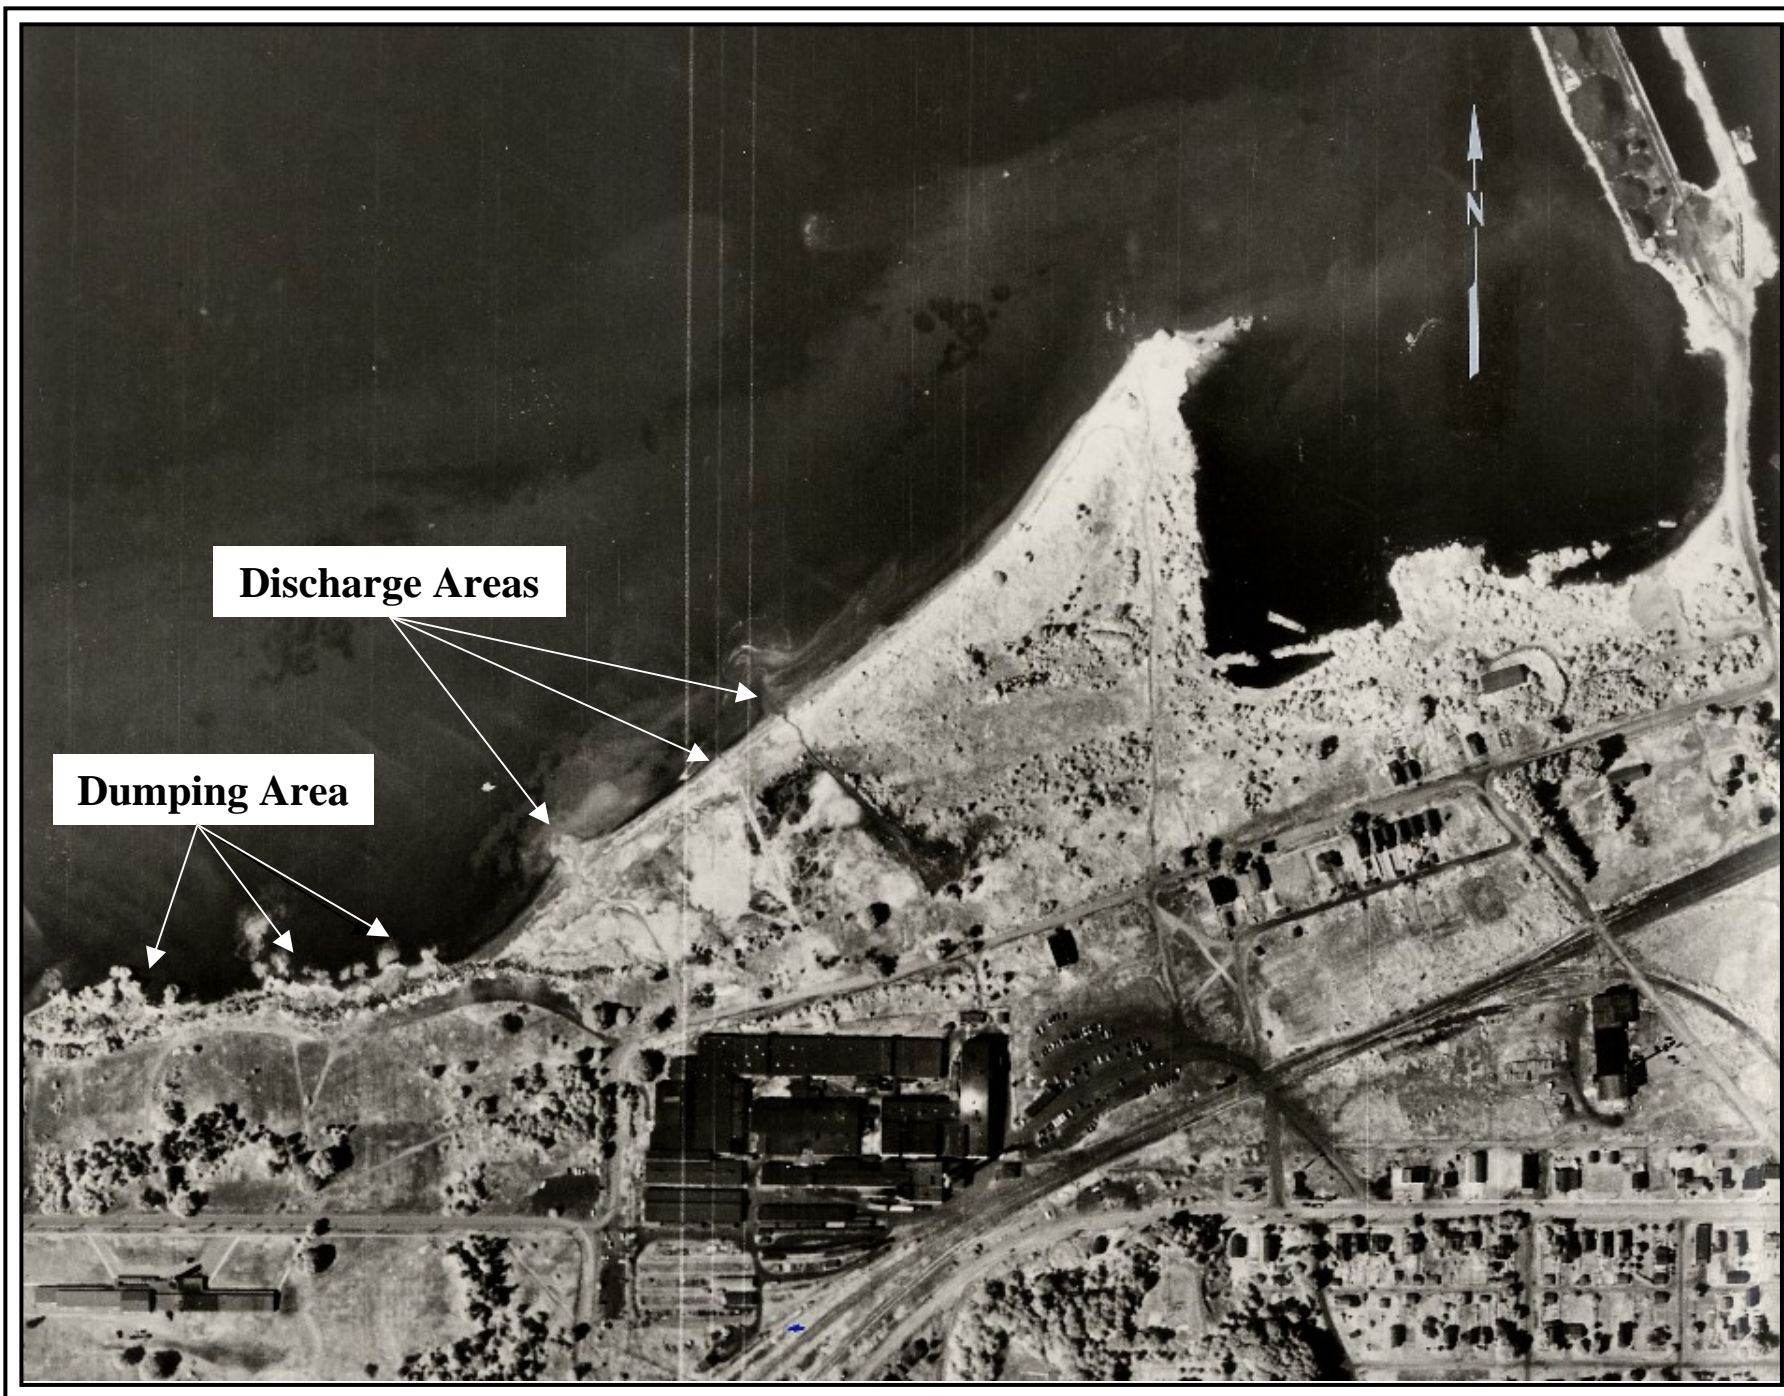
Figure 3. Tannery Plant and Discharge and General Waste Dumping Areas, August 10, 1953

The Western Shoreline area, Zone A, was also used as a dump site for barrels and general wastes from the tannery. According to former employees of the tannery, approximately two truck loads of plant wastes were disposed of per day. These wastes were typically burned after disposal. The former Tannery Plant and waste discharges are shown on Figure 3.
